VACUUM INSULATOR FAILURE MEASUREMENTS AND IMPROVEMENT*

G. E. VOGTLIN, J. E. VERNAZZA
LAWRENCE LIVERMORE NATIONAL LABORATORY
UNIVERSITY OF CALIFORNIA
LIVERMORE, CA 94550

ABSTRACT

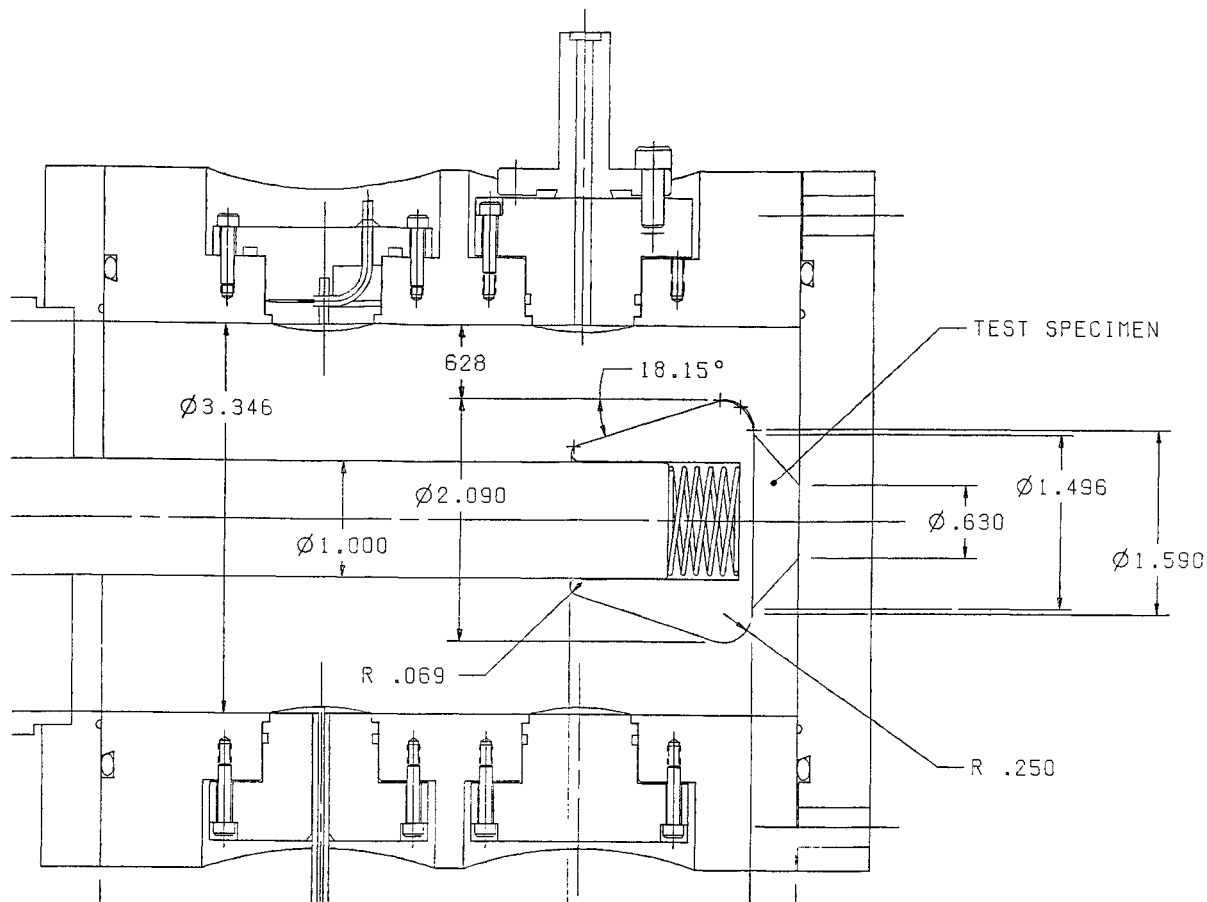
Fig. 1. TEST SETUP

The 3-ns pulse used was constructed by Scarpetti and described in Ref. [6]. The electrode and insulator arrangement is shown in Figure 1.

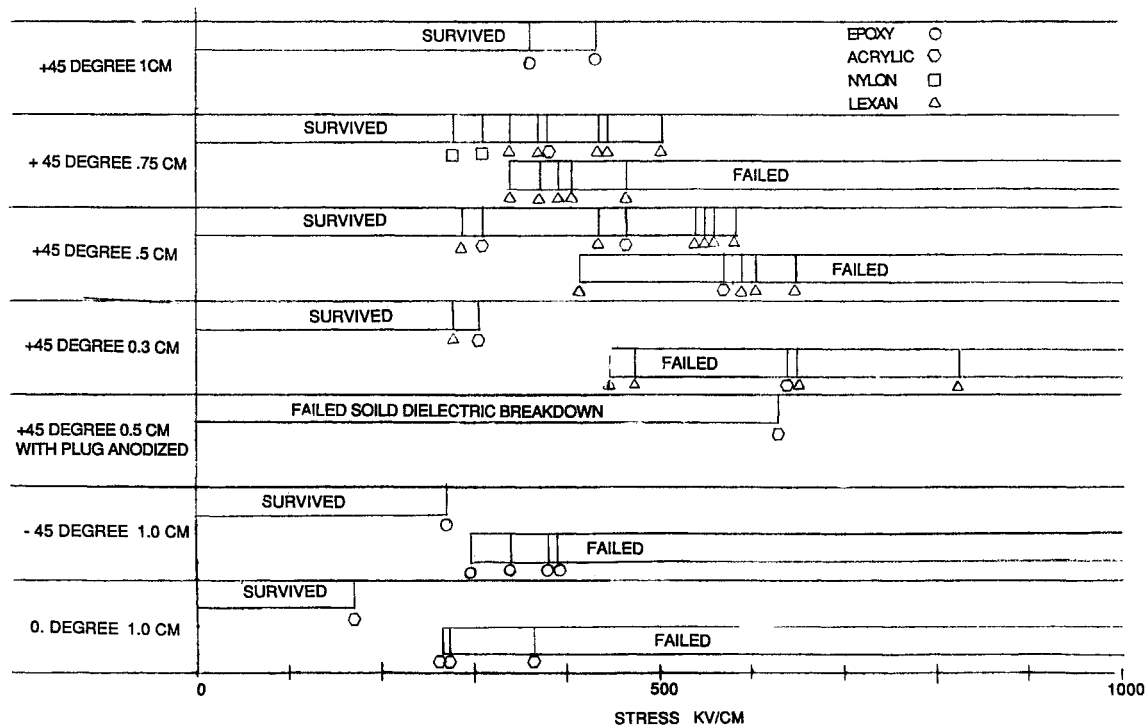
Fig. 2. INSULATOR FAILURE-SURVIVAL CHART

Specimens tested either held the 3 nanosecond pulse or failed during the pulse. Figure 2 shows results of this testing. The first bar on the top shows 3 specimens 1 cm high and a +45° angle. They survived 360 kV/cm and 430 kV/cm. No specimens failed since this was close to the voltage limit of the pulser. The second bar is for +45° 0.75 cm specimens, 7 specimens survived and 5 specimens failed. The highest survival was 505 kV/cm with a Lexan specimen and the lowest failure was 310 kV/cm with a nylon specimen. Data is presented for an angle of +45° with .5 cm and .3 gaps. Other angles are -45° and 0° with 1 cm specimen. The highest level was achieved with a 0.5 cm acrylic specimen with an anode plug to relieve the anode stress and an anodized aluminum cathode surface. The failure was at 620 kV/cm. This failure, however, was through the solid dielectric from the plug to the cathode. A description of this specimen is given in Ref. [5].

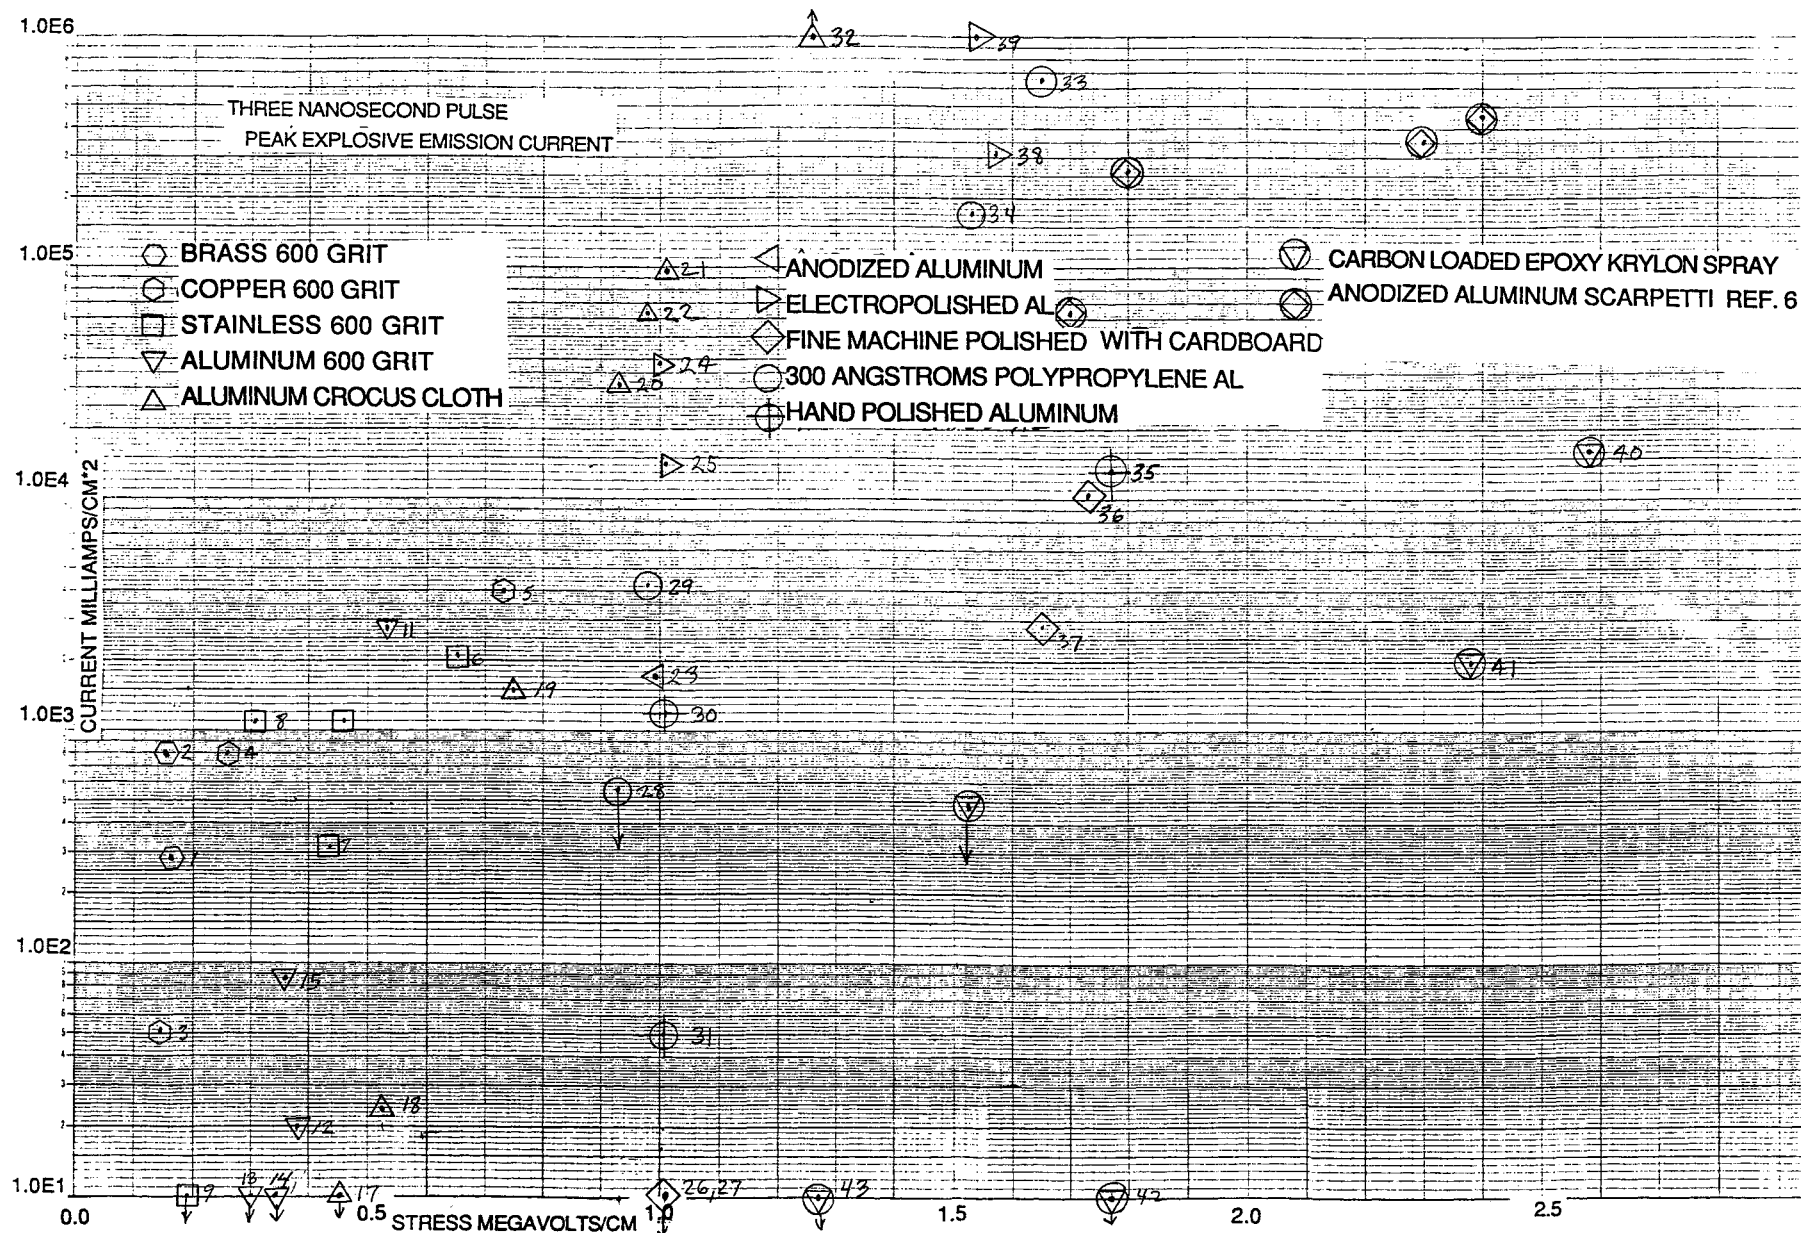
Fig. 3. PEAK EXPLOSIVE EMISSION CURRENT VS STRESS

Field emission was measured with the same apparatus as described in Reference [5]. Figure 3 (current vs stress) shows the results for various metal surfaces. The surfaces tested from 100 kV to 800 kV/cm were finished with 600 grit or crocus cloth. Brass with a 600 grit finish gave a peak current of 800 milliamps with a peak stress of 180 V/cm. If we assume an emission per point of 100 ma, then there would be 10 emission points. This is in an area of .785 cm² or 12 points/cm².

Figure 3 from 800 kV to 1.8 meV/cm shows materials such as anodized aluminum and electron polished stainless steel. One specimen held 1mV/cm without measurable current. This specimen was fine machined stainless steel, polished on a lathe with a piece of cardboard. The next best was an aluminum specimen coated with 300 angstroms of polypropylene, which emitted 50 ma at 1 mV/cm.

Another surface tested was aluminum coated with a carbon filled epoxy. The epoxy coating was approximately 0.1 millimeters thick with a surface resistivity of 200-800 KΩ per square. This surface was polished with paper and sprayed with krylon spray, matte finish. Figure 3 shows this surface did not have any measurable emission at 1.7 megavolts/cm. It emitted 3 amps at 2.3 megavolts/cm. This current probably represents no more than two explosive emission points.
